Manhole Inspection Summary

Manhole # S43AA_034MH

Insp Date: **6/24/08 8:35 AM**

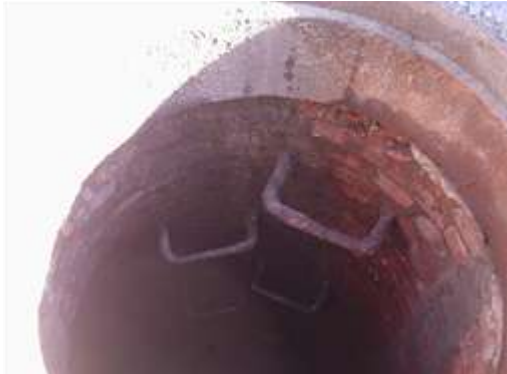
Defect 1

Frame Offset: **0** (in.) Condition: ☐ Sound ☐ Cracked ☒ **Leaks**

Frame Leaks

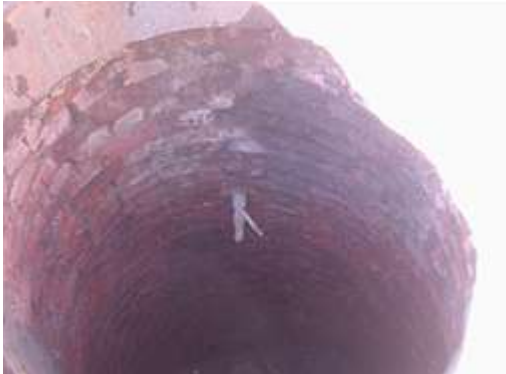
Defect 2

Chimney / Frame Adjustment ☒ Exists Material: **Brick** ☐ Parged Height: **3** (in.)
Condition: ☐ Sound ☐ Cracked ☐ Root Intrusion ☒ **Loose Brick** ☐ Deteriorated
Infiltration: ☐ None ☐ Joint ☐ Cracks ☒ **Mortar** ☐ Roots ☐ Wall

Corbel Material: **Brick** ☐ Parged Type: **Concentric/Eccentric**
Condition: ☒ Sound ☐ Cracked ☐ Root Intrusion ☐ Loose Brick ☐ Deteriorated
Infiltration: ☐ None ☐ Joint ☐ Cracks ☐ Mortar ☐ Roots ☒ **Wall**

Barrel Material: **Brick** ☐ Parged
Shape: **Circular** Diameter: **42** (in.) Length: (in.)
Condition: ☒ Sound ☐ Cracked ☐ Root Intrusion ☐ Loose Brick ☐ Deteriorated
Infiltration: ☐ None ☐ Joint ☐ Cracks ☐ Mortar ☐ Roots ☒ **Wall**

Infiltration

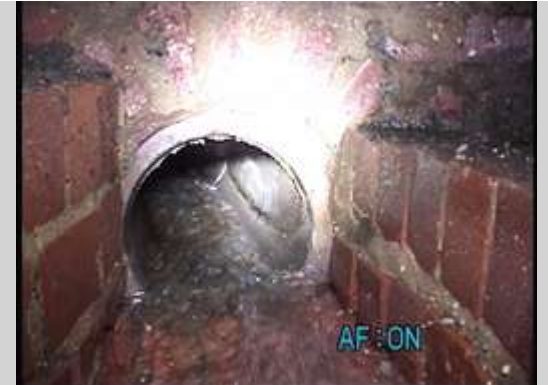
12 O'Clock Outflow

8 in. Circular Gravity Sewer
Pipe Out @ 12 O'Clock

Pipe Height: **8.4** (in.) Rod and Bar (Angled)
Pipe Material: **Clay** ☐ Pipe Lined
Invert Depth: **10.55** (ft.) Flow Characteristics: **Fast**
Deposits: ☒ None ☐ Mud ☐ Sludge ☐ Debris ☐ Grease
Silt Depth: (in.) Deposits Extent:
Infiltration: **None** Pipe Seal Cond: **Sound**

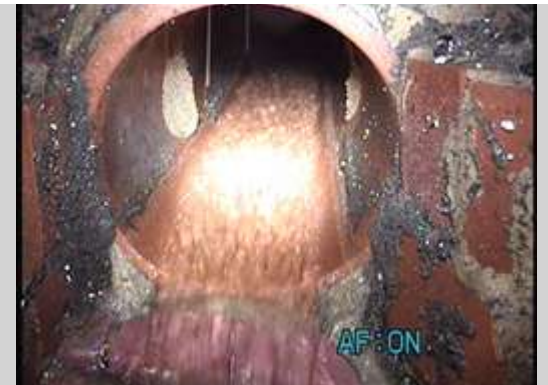
9 O'Clock Inflow

8 in. Circular Gravity Sewer
Pipe In @ 9 O'Clock

Pipe Height: **8.4** (in.) Rod and Bar (Angled)
Pipe Material: **Clay** ☐ Pipe Lined
Invert Depth: **10.10** (ft.) Flow Characteristics: **Fast**
Deposits: ☒ None ☐ Mud ☐ Sludge ☐ Debris ☐ Grease
Silt Depth: (in.) Deposits Extent:
Infiltration: **None** Pipe Seal Cond: **Sound**
